TACTICAL BRIDGE ACCESS//GRESS PRELIMINARY
INVESTIGATIONS(U) ARMY ENGINEER WATERWAYS EXPERIMENT
STATION VICKSBURG MS GEOTECHNICAL LAB B A MATIS SEP 80

*Tactical Bridge Access/Egress
Preliminary Investigation*

Case, Gordon L.; Green, Hugh L.; Taylor, Hugh M. Sept. '80

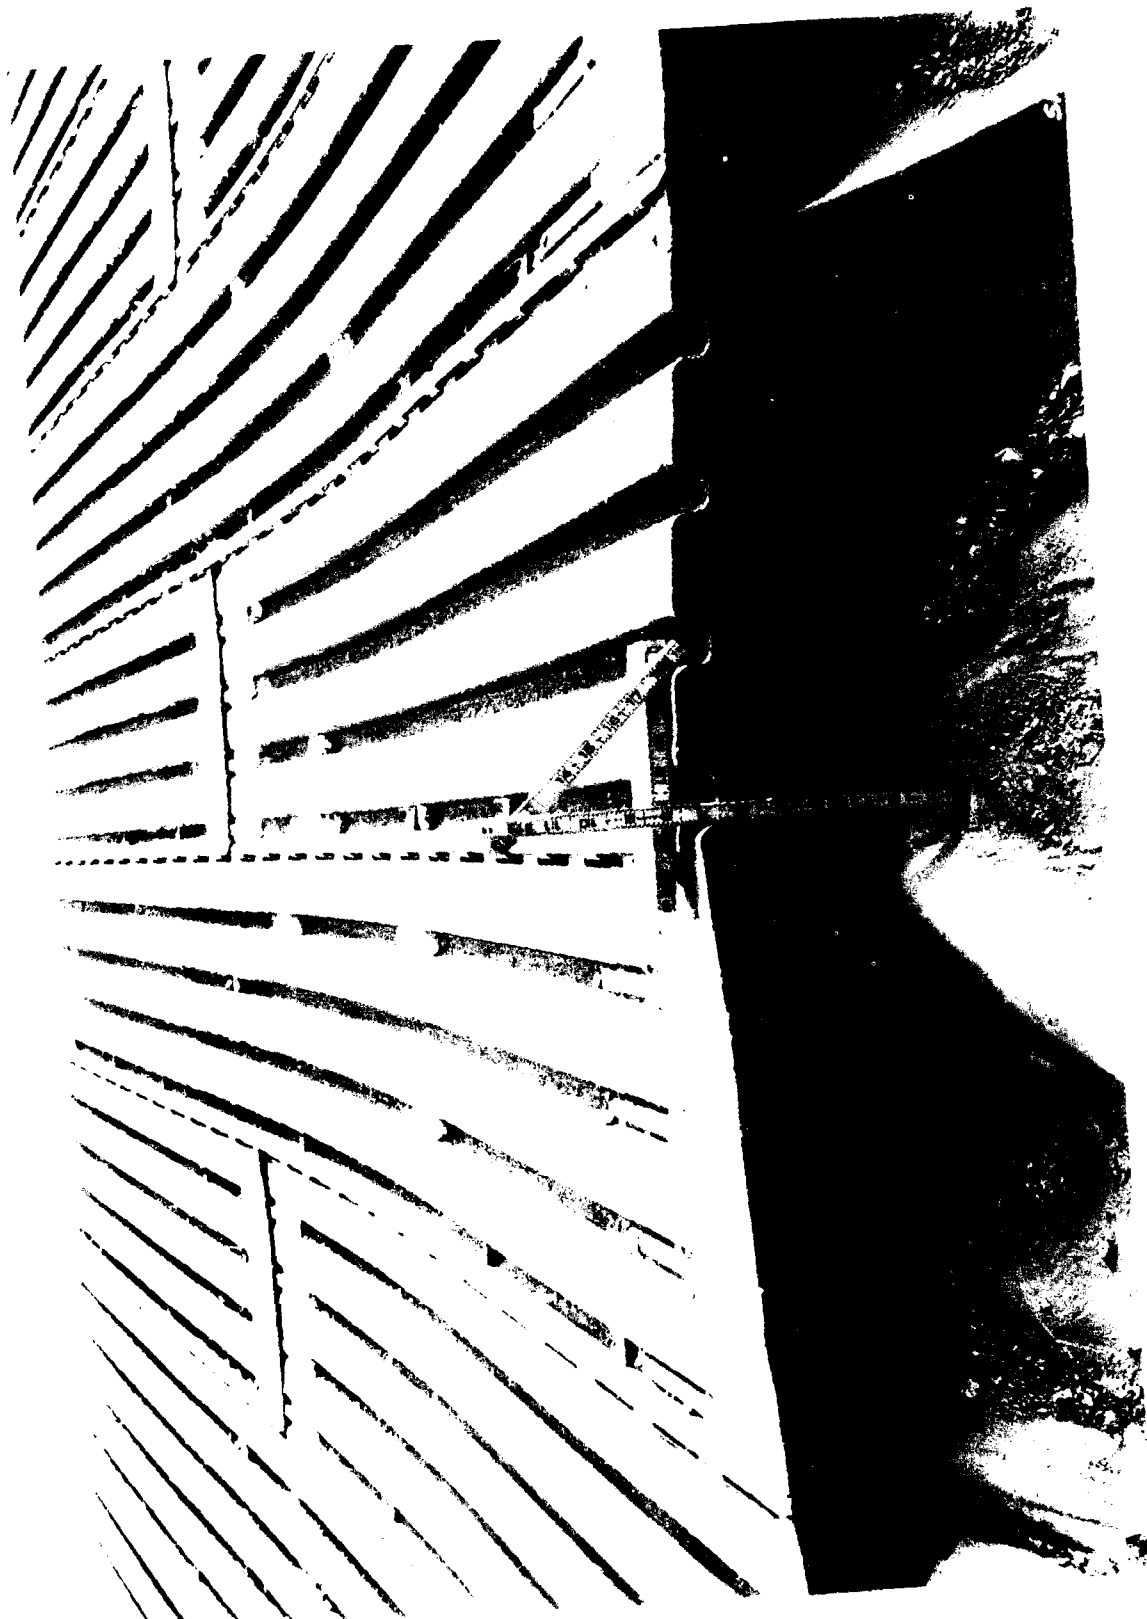
Close up of the east mat edge after 2000 total passes

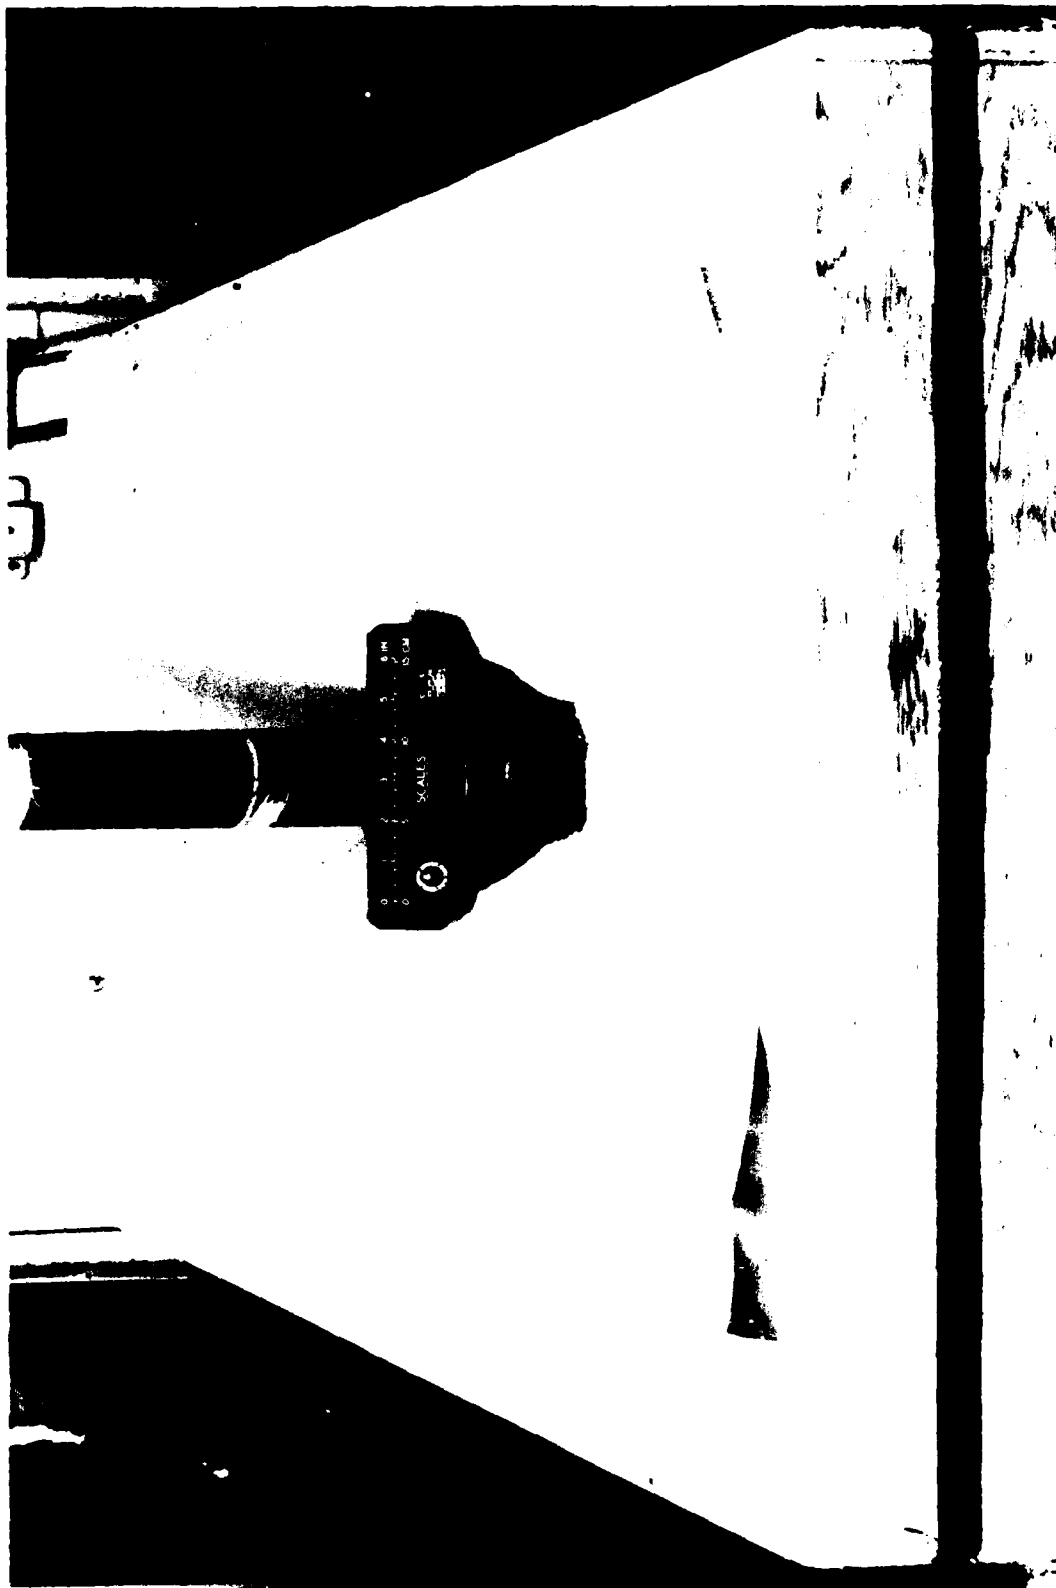
Failure of aluminum grid in laboratory test

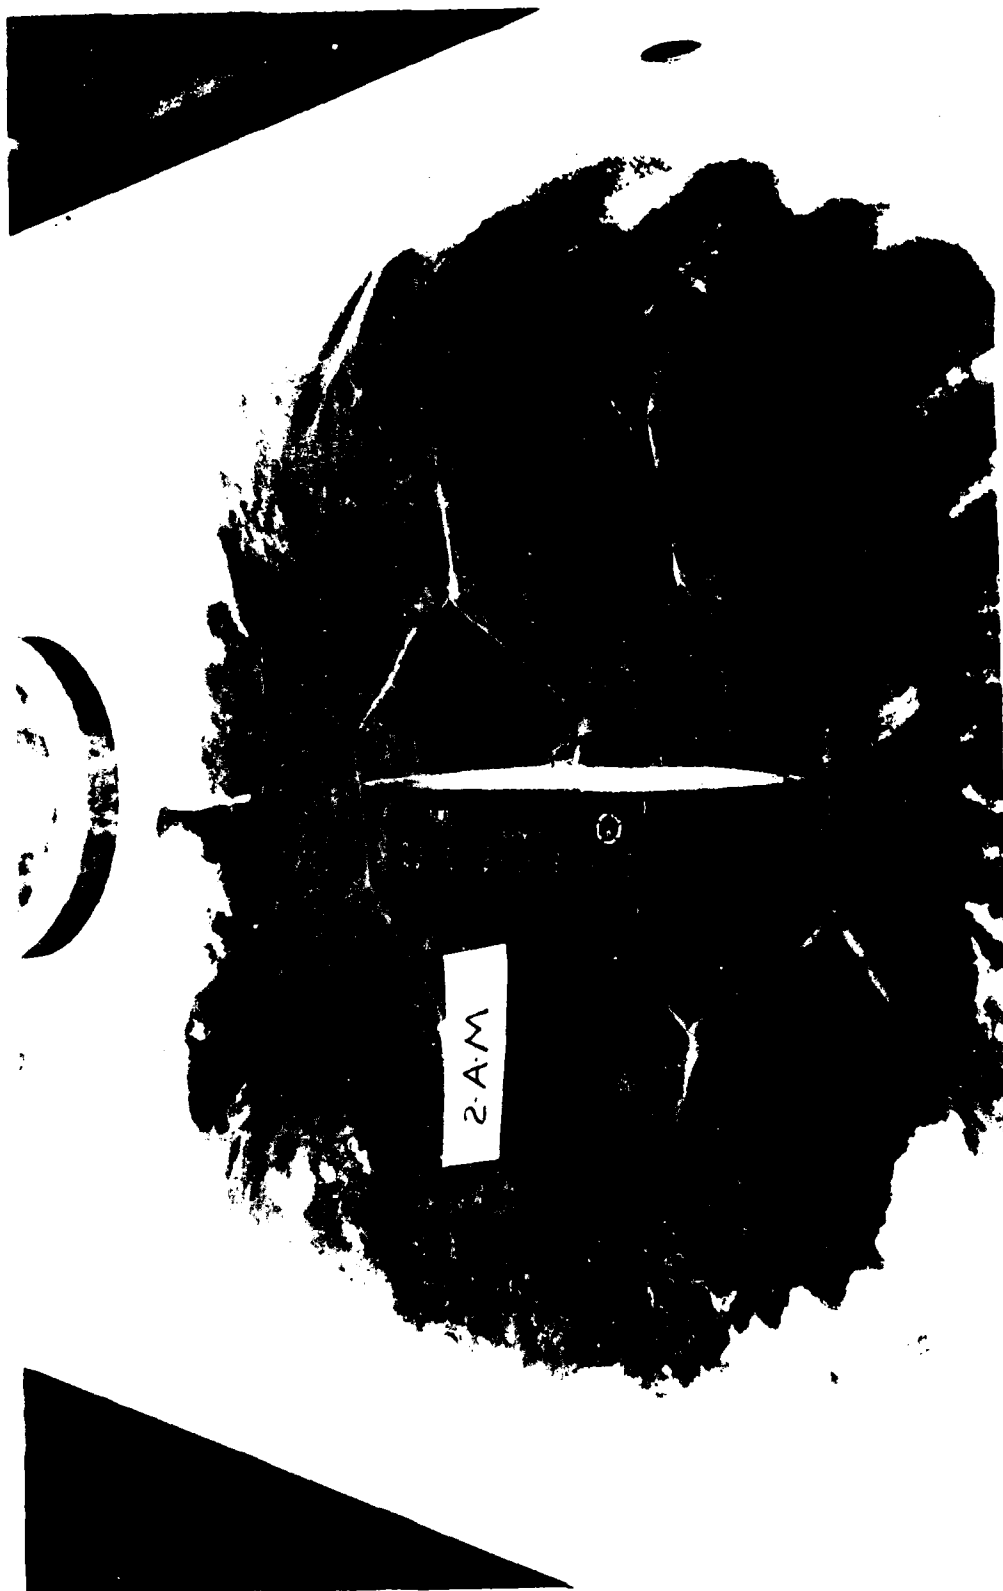
Membrane failure in laboratory tests

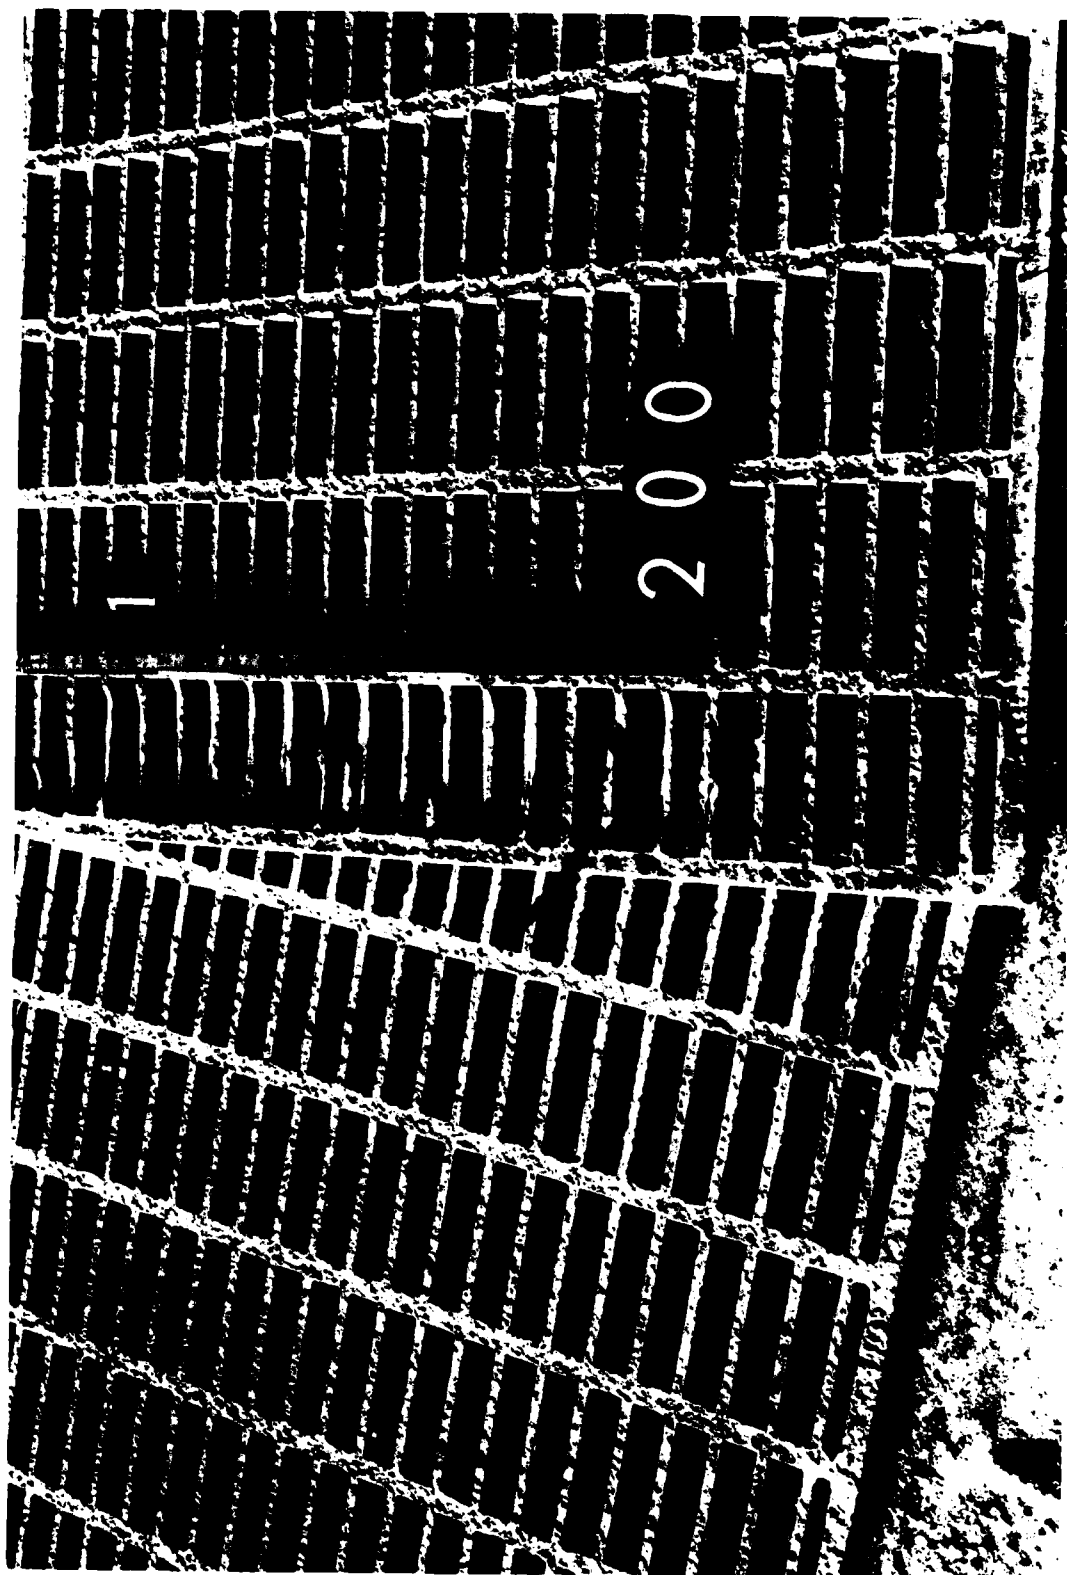
Abrasive wear on panel in item 1 after 200 passes of traffic

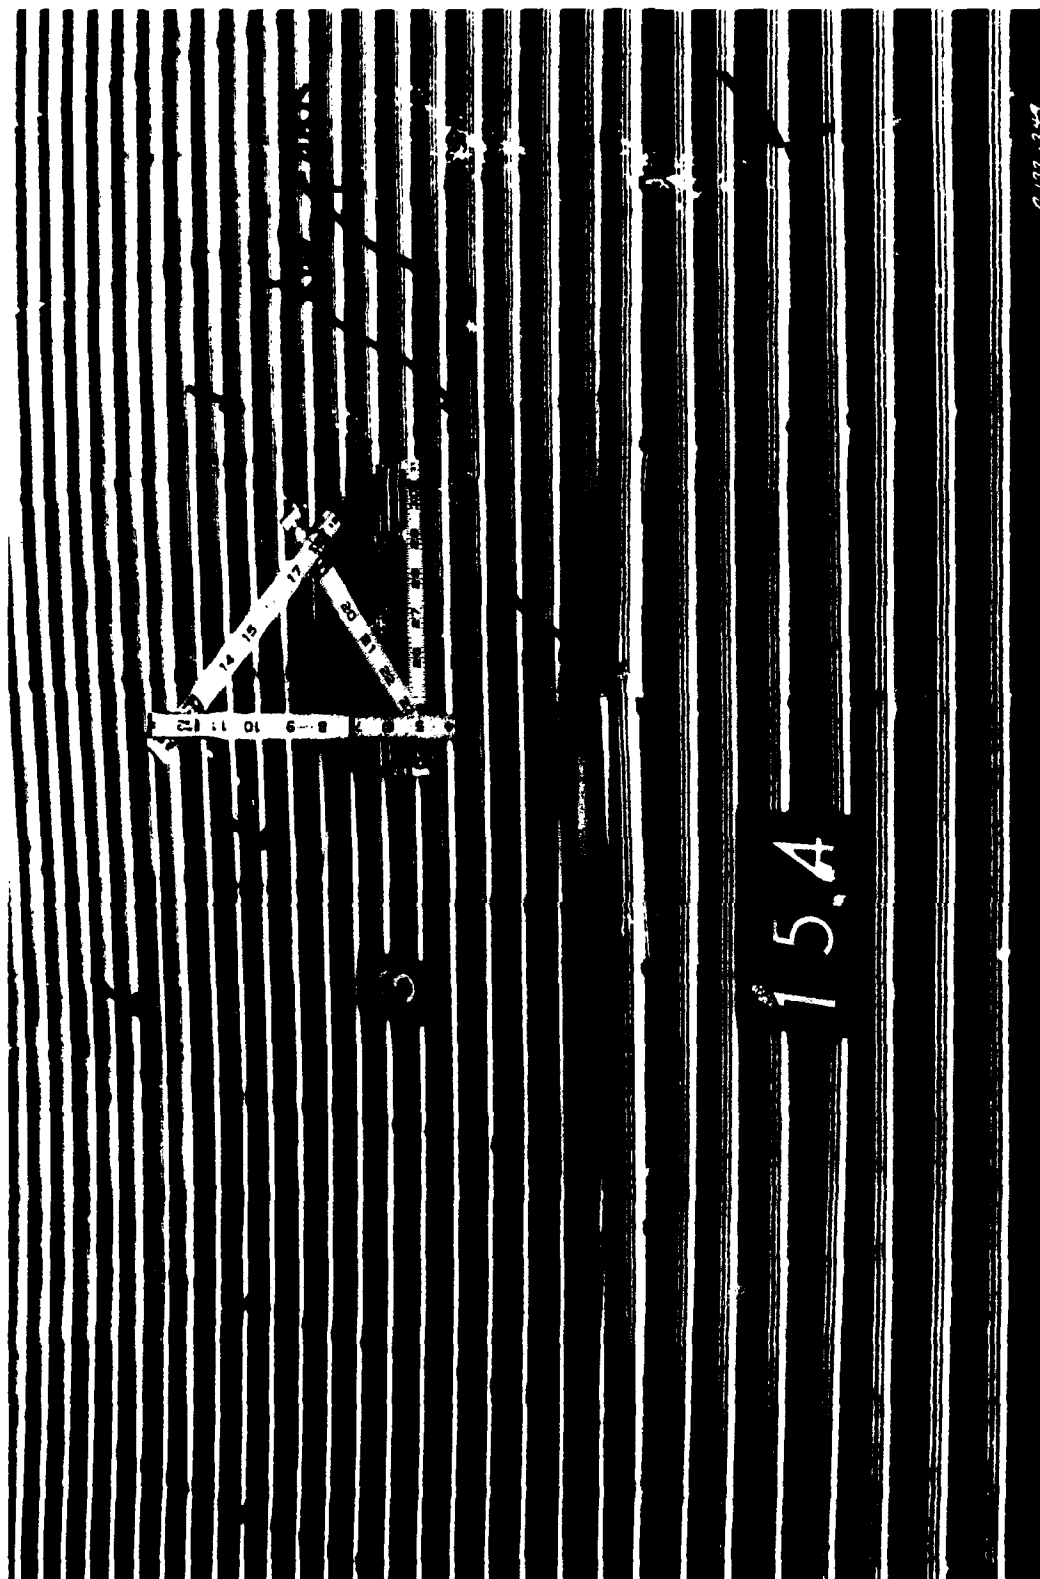
Close up of failures in item 3 after 154 passes of traffic

28. The fiberglass panels increased the trafficability of the subgrade severalfold and indicated potential for access/egress applications. Design improvements recommended for the fiberglass panels included integral side connectors and a method of anchoring the panels in both sand and clay subgrades.

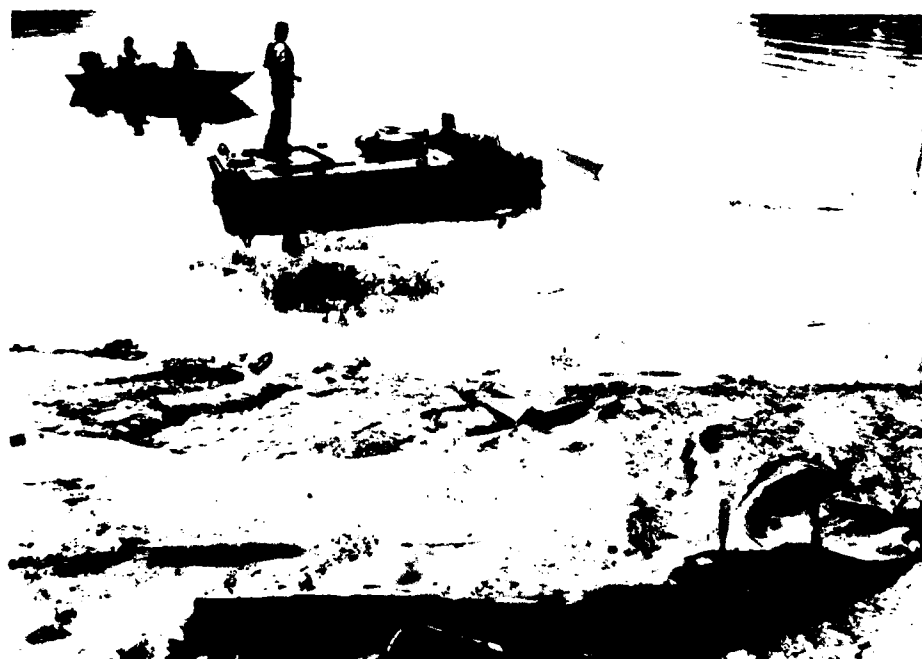
l. Vehicle immobilized by membrane entangled in track system

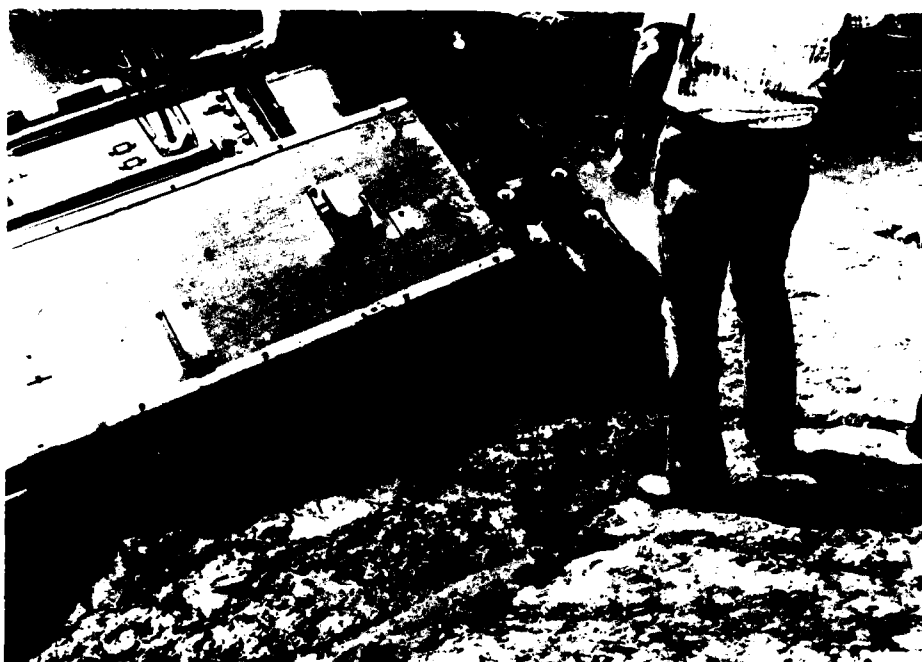
m. Vehicle being pulled from lake, showing damage to left sprocket

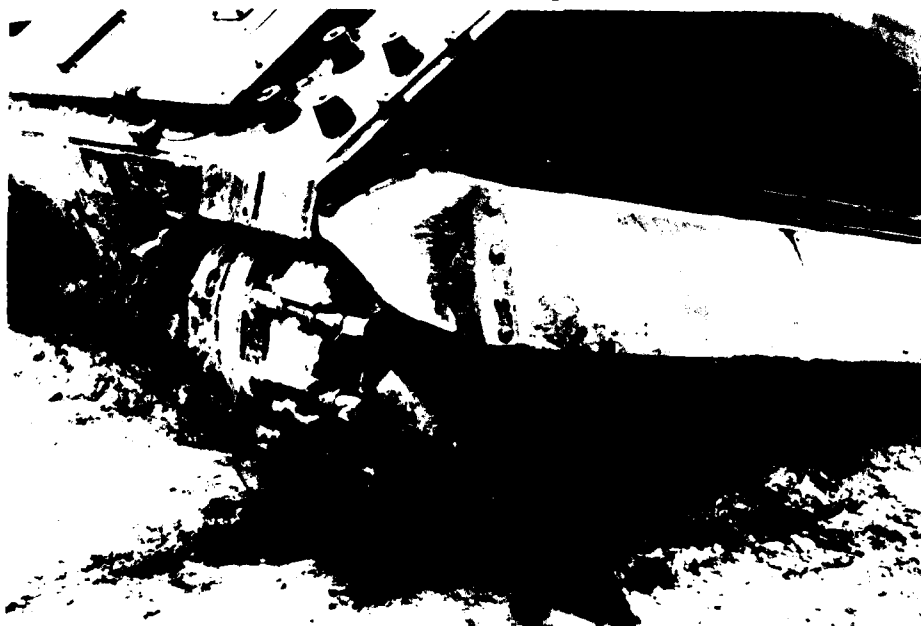
n. Membrane entangled in left sprocket (note steel anchor cable in sprocket, which may have caused initial entanglement)

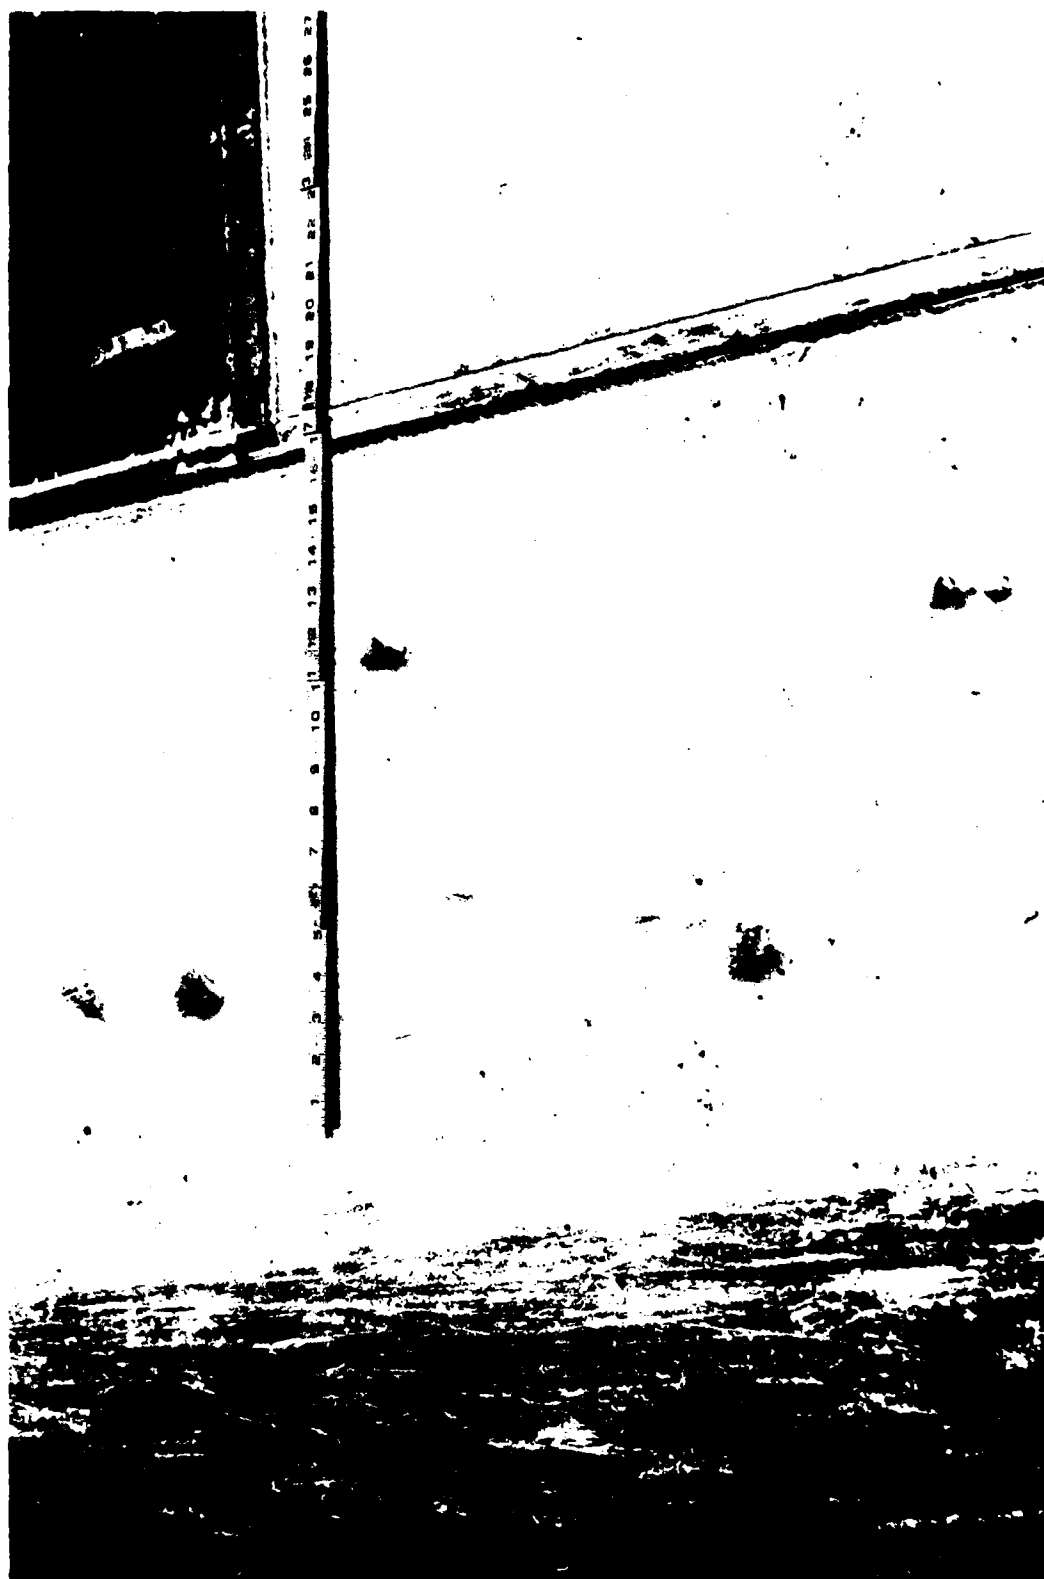
Figure I9. Antiskid abraded from the M19 mat caused by soil and traffic
